SEAA 1321

On July 12, 2011, I conducted a calibration inspection of most of the Diversions on East Fork of the Virgin Distribution System. I was accompanied by the new Water Commissioner, Jeff Medlin. For the Orderville diversion, this was a follow up to the October 7, 2008 inspection conducted with the previous commissioner, Gerry Hoyt. A second inspection around that time was done on July 21, 2009. A number items still require attention:

**Flow over Standard  
 contracted Cipoletti weir**

11.3 foot wide Cipolletti Weir

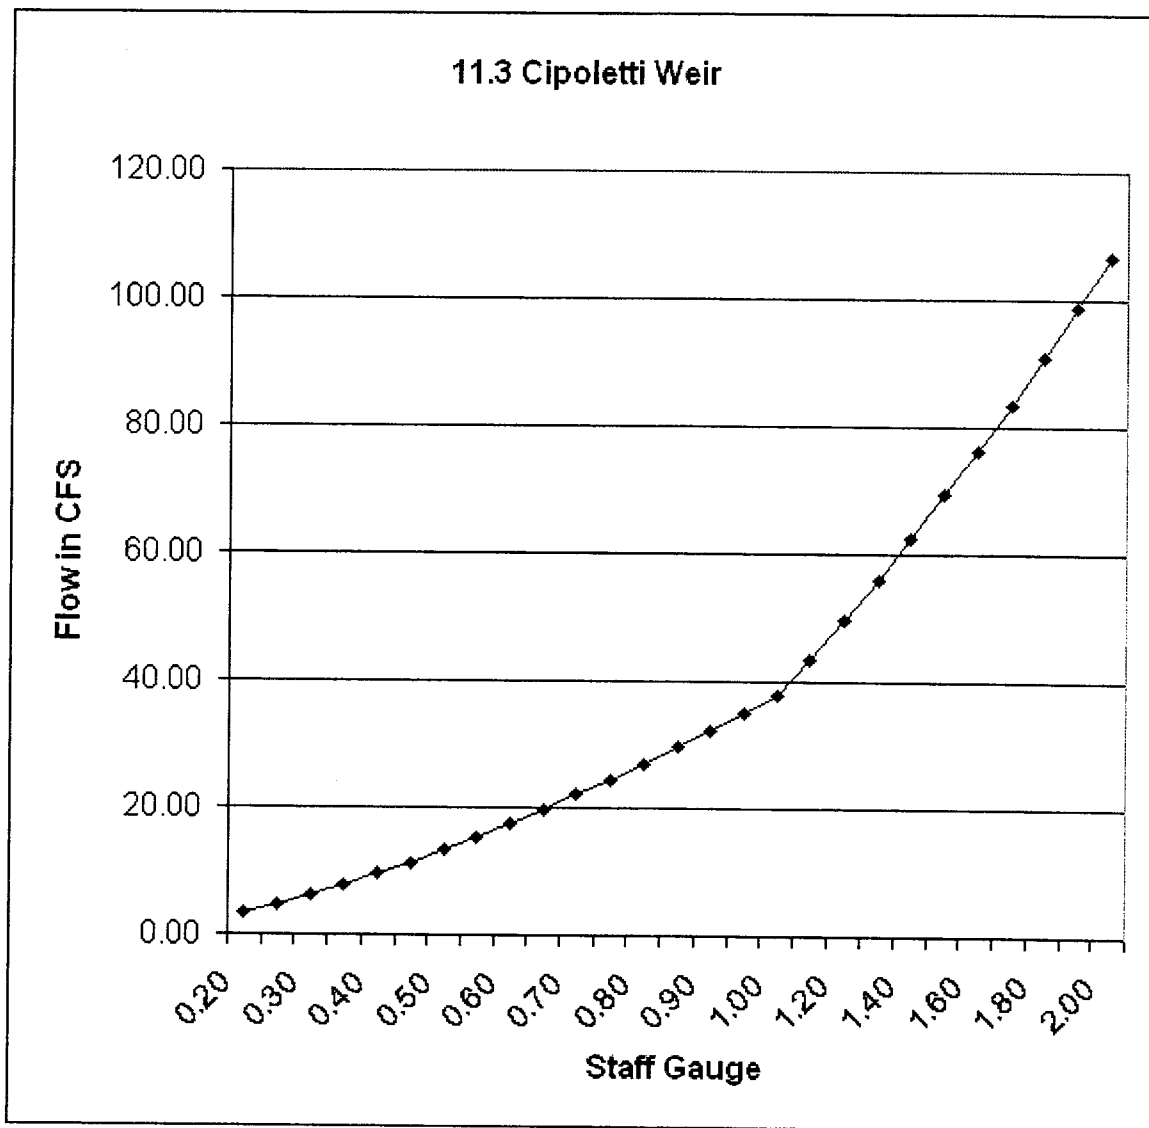
Height over Weir	Flow
Height in Feet	CFS
0.20	3.37
0.25	4.71
0.30	6.20
0.35	7.81
0.40	9.54
0.45	11.38
0.50	13.33
0.55	15.38
0.60	17.52
0.65	19.76
0.70	22.08
0.75	24.49
0.80	26.98
0.85	29.55
0.90	32.19
0.95	34.91
1.00	37.70
1.10	43.50
1.20	49.56
1.30	55.89
1.40	62.46
1.50	69.27
1.60	76.31
1.70	83.57
1.80	91.06
1.90	98.75
2.00	106.65

Most notable was measurement calibration: we checked the width of the weir crest and measured 11.3 feet wide, with slanted sides, this make it a "Cipoletti" style weir. If you have a calibration table for a 11.3 wide Cipoletti weir, we can use that, otherwise, I have developed a calibration table for an 11.3' Cipoletti weir (attached). To insure accurate readings, the staff gauge should be checked for level when the sluice basin is drained. The Staff gauge should be checked to insure its mounted level with the crest of the weir, and it should be checked for level side to side. The staff gauge must be kept clean.
